Arboricultural Hazard Assessment

Site Address: Shipton by Beningbrough
Various Sites

Report Ref: SBB02-26

Report Date: 17th April 2026

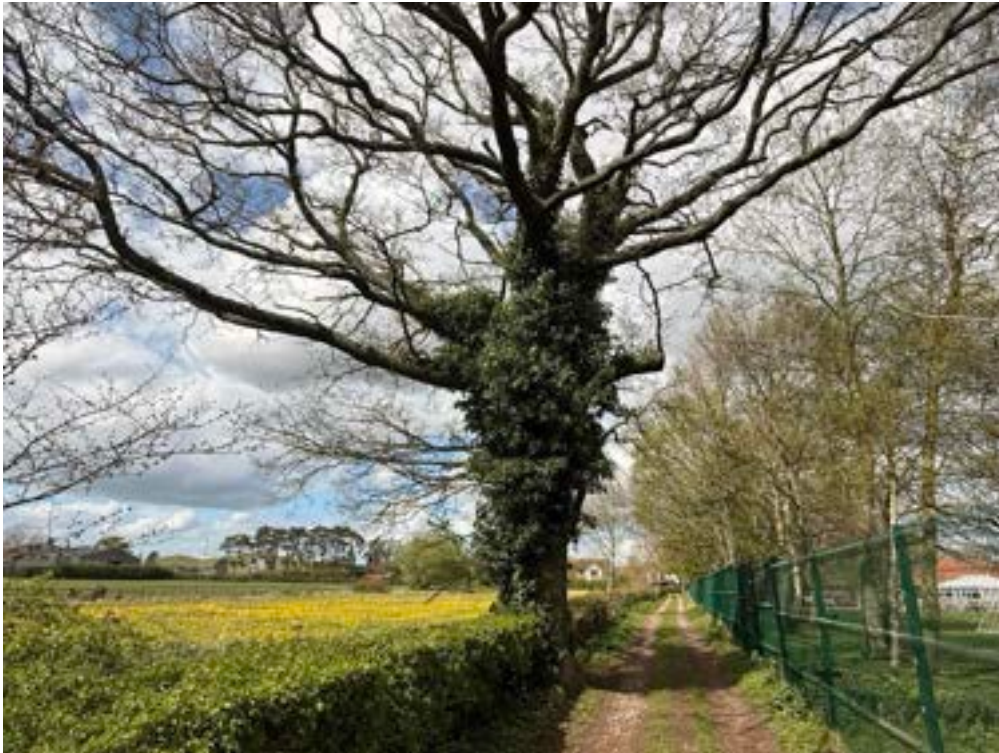
ID	Age Class	Species	Height (m)	Crown Spread	Diameter (mm)	Vitality	General Observations	Risk Assessment of	Target Range	Size Range	PoF	Reduce Mass to	Risk of Harm	Management Recommendations	Figure ref.
T1	Semi Mature	Ash (<i>Fraxinus excelsior</i>)	11	6	420	Normal	<p>The tree is located on the boundary shared with the adjacent school. A damaged limb was previously present at approximately 5 m, with a reasonable potential for further failure. Several additional torn and broken branches were noted within the canopy; however, these were not considered to pose a significant risk.</p> <p>2026: Previously damaged limbs have either failed or been removed. No new defects or observations were identified.</p>	-	-	-	-	-	<1/1M	No works recommended at present. Continue to monitor the condition, particularly for any development of defects within the primary unions.	Fig. 1
G2	Semi Mature	Ash & Oak (<i>Fraxinus & Quercus</i>)	10 - 18	N/A	400-900	Normal	<p>A group of trees located on either side of the access track to the allotments, comprising three Ash and one Oak. In addition, several Maples from the adjacent school grounds extend over the track.</p> <p>The Ash trees exhibit minor cambial damage, likely associated with repeated impact from high-sided vehicles using the access route.</p> <p>2026: The northernmost Ash shows signs of minor canopy decline and the development of internal epicormic growth, which may be indicative of early-stage Ash Dieback infection.</p>	Falling branches	4	3	7	-	<1/1M	No immediate works required. Continue to monitor Ash trees for progression of Ash Dieback. Consider periodic pruning to maintain clearance over the access track if vehicle conflict persists.

Figure 1. T1 clad in Ivy.

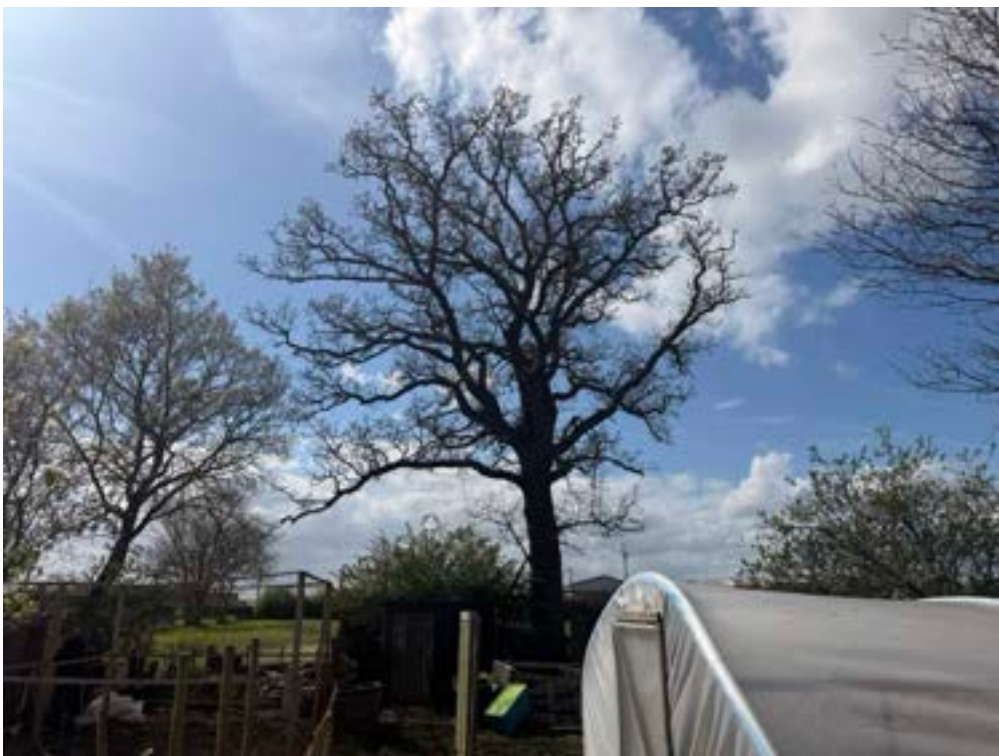
T3	Mature	Oak (<i>Quercus robur</i>)	18	6	900	Normal	<p>A large tree located along the field boundary. Numerous instances of small-diameter deadwood are present throughout the canopy. One larger dead limb extends over the adjacent school; however, this appears well attached at present.</p> <p>Minor cambial damage is evident around the base on the eastern aspect, though this is not currently considered significant.</p> <p>2026: Deadwood remains present within the canopy. The stem is becoming increasingly clad in Ivy, which may obscure visibility of potential defects and limit the effectiveness of visual inspection.</p>	Falling deadwood	4	4	4	25%	<1/1M	Consider removal or severance of Ivy to improve visibility for inspection and reduce potential long-term impact on the tree.	Fig. 2
T4	Mature	Oak (<i>Quercus robur</i>)	15	5	860*	Reduced	<p>A mature tree located along the boundary, exhibiting notably low vigour and minor deadwood throughout the canopy. The reduced condition is likely attributable to ongoing disturbance within the neighbouring field, potentially associated with repeated ploughing impacting the rooting environment.</p> <p>2026: The tree continues to exhibit low vigour; however, there are no clear signs of progressive dieback at this time.</p>	Falling deadwood	5	4	4	25%	<1/1M	No works recommended at present. Continue to monitor the condition given reduced vigour.

Figure 2. T3 is displaying low vigour.

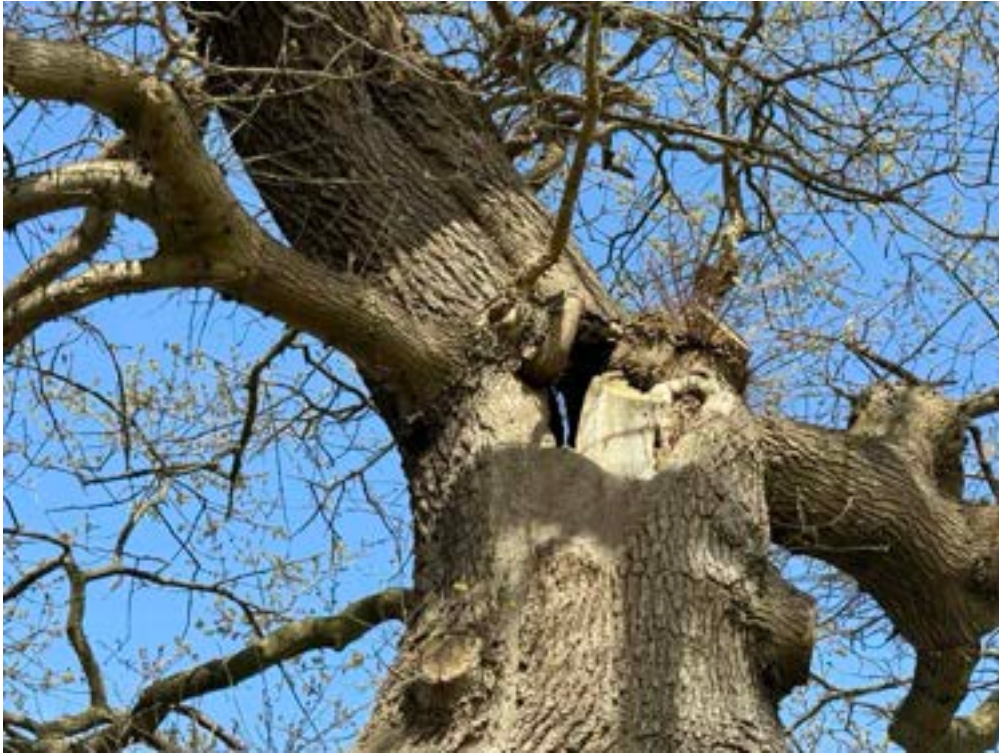
The only tree requiring significant intervention is T22, where extensive internal decay and reduced residual wall thickness have been identified. While the tree retains ecological and amenity value, the structural condition warrants management. A substantial crown reduction to form a pollard is recommended to reduce loading on the compromised stem while facilitating retention of the tree in a reduced form.

ID	Age Class	Species	Height (m)	Crown Spread	Diameter (mm)	Vitality	General Observations	Risk Assessment of	Target Range	Size Range	PoF	Reduce Mass to	Risk of Harm	Management Recommendations	Figure ref.
G5	N/A	Mixed	3 - 17	N/A	N/A	N/A	A group of trees located to the north-west of the allotment, comprising three Oak and two Plum specimens.	-	-	-	-	-	<1/1M	No work required.	
T22	Post Mature	Oak (<i>Quercus robur</i>)	15	7.5	1000 est.	Reduced	<p>A post-mature Oak exhibiting extensive internal hollowing, extending from approximately 1 m to 9 m along the main stem. At circa 8 m, the extent of decay is visible, indicating a significantly reduced residual wall thickness.</p> <p>While the majority of canopy weight is biased towards the adjacent field, this does not guarantee the direction of failure. The tree is located within a low target area and retains a relatively high ecological and amenity value.</p>	Stem failure	2	1	4	-	1/40K	Undertake a significant crown reduction to form a pollard at approximately 10 m, reducing loading on the compromised stem while retaining the tree for its ecological value.	Fig. 3

Figure 3. T22 with a hollowing stem.

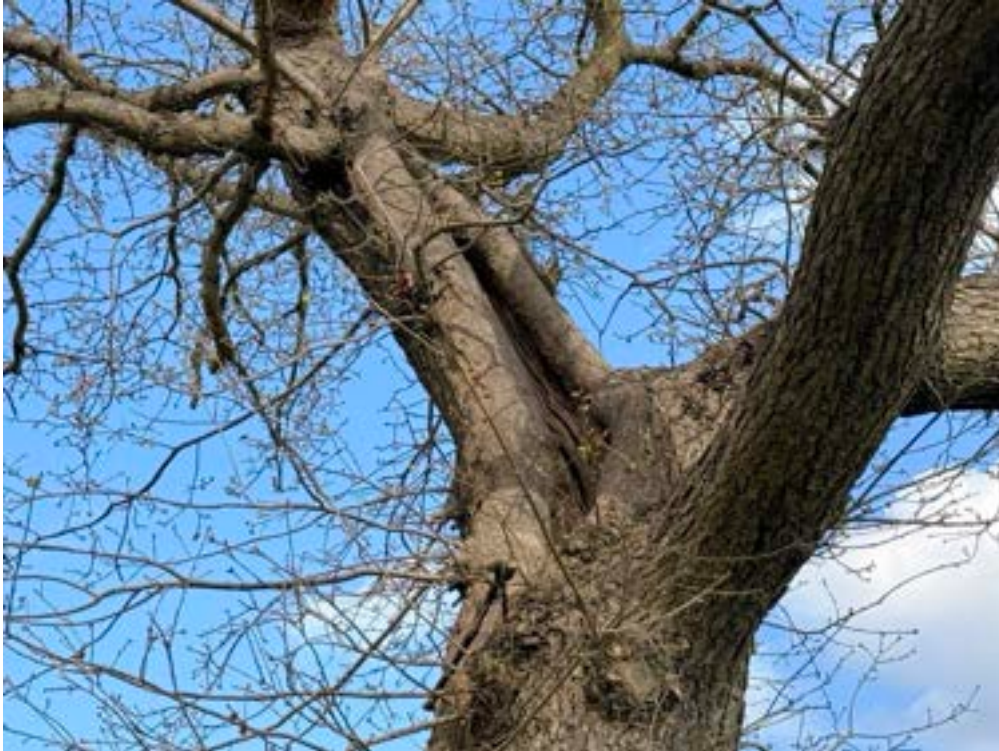
G6	Post Mature	Oak (<i>Quercus robur</i>)	15	5	1000*	Reduced	<p>A group of two Oaks located just outside the site boundary, both leaning away from the allotment. The stems exhibit significant internal hollowing associated with cubical brown rot. Despite this, there is strong reaction growth surrounding open cavities, suggesting that residual structural integrity remains.</p> <p>In the event of failure, the most likely direction would be towards the adjacent field. Given the low target occupancy, the trees are not considered to present a significant risk and offer high habitat value.</p> <p>2026: No significant defects or changes in condition were observed.</p>	Stem failure	5	1	6	-	<1/1M	No works recommended. Retain trees as habitat features, given low target occupancy and high ecological value.	Fig. 4
G7	Mature	Ash & Holly (<i>Fraxinus & Ilex</i>)	9.5 ave.	4	N/A	Normal	Two trees are located at the edge of the allotment, comprising one Ash and one Holly. Both trees are in good physiological condition, with no significant defects observed. The Ash shows no visible signs of Ash Dieback at the time of inspection.	-	-	-	-	-	<1/1M	No works required.

Figure 4. Hollowing on a limb of a tree within G6

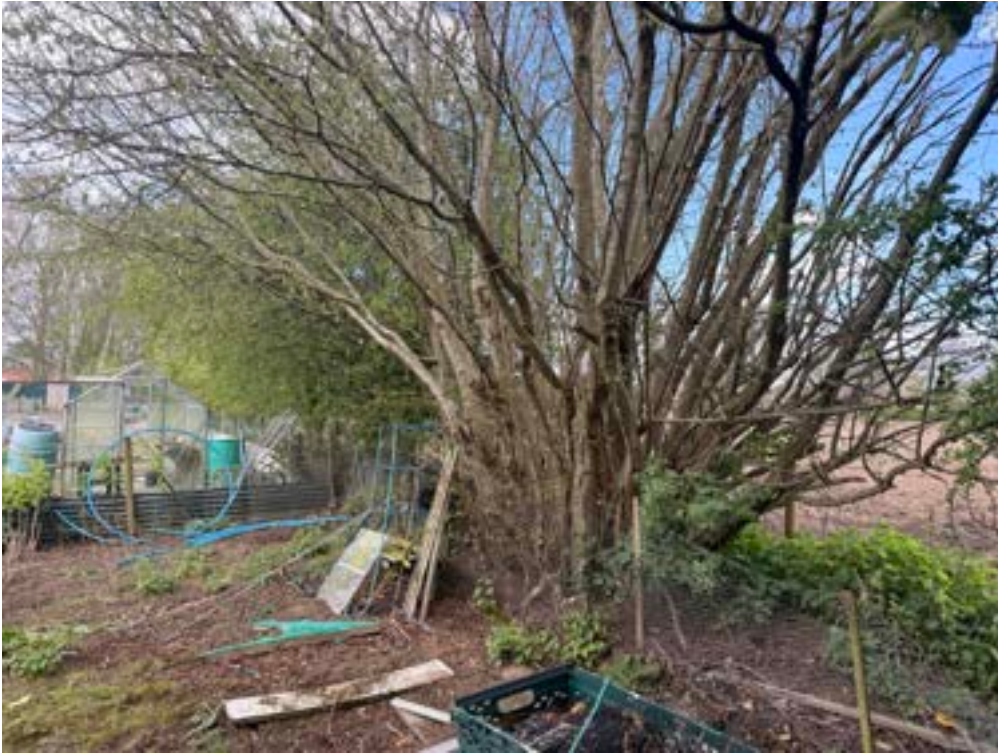
G8	Semi Mature	Hazel & Laurel (<i>Corylus & Prunus</i>)	6	4.5	100	Normal	A group comprising three Hazel coppice stools and one Laurel, all exhibiting multiple stems arising from ground level. The trees are in generally good condition and present a low level of risk; however, continued growth may result in the development of elongated, potentially unstable stems if not managed.	Stem failure in Hazel	5	4	6	-	<1/1M	Re-coppice Hazel stools to manage size and prevent stem failure associated with overextension.	Fig. 5

Figure 5. A Hazel copice within G8 which has not been recently managed.

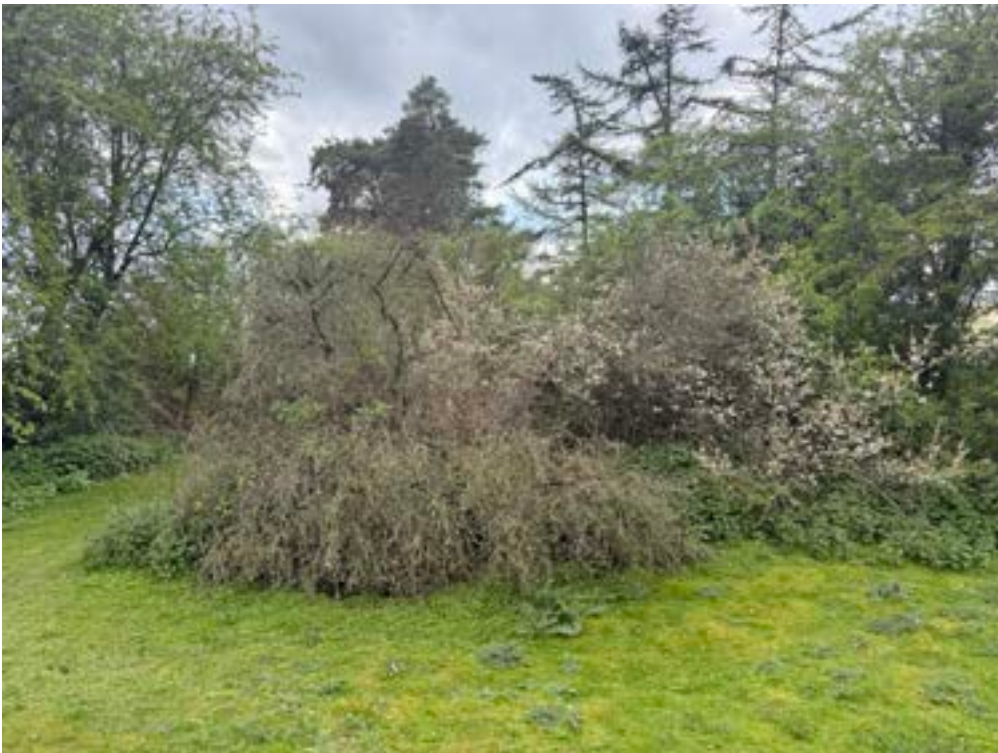
ID	Age Class	Species	Height (m)	Crown Spread	Diameter (mm)	Vitality	General Observations	Risk Assessment of	Target Range	Size Range	PoF	Reduce Mass to	Risk of Harm	Management Recommendations	Figure ref.
G9	Mature	Mixed	N/A	N/A	N/A	N/A	A small area of open parkland containing four Whitebeam, two Hawthorn, and one fallen Plum. The Plum remains alive despite stem failure and is currently supported by the ground. Due to the absence of targets beneath the canopy, the tree does not present a significant risk. 2026: Further failure of the Plum has occurred, with one of the two main stems now entirely dead. The tree continues to provide low-level habitat value through associated scrub development.	-	-	-	-	-	<1/1M	Retain the fallen Plum as a habitat feature. Removal may be considered for aesthetic or management reasons; however, this would not reduce risk and may reduce ecological value.	Fig. 6
T10	Mature	Oak (<i>Quercus robur</i>)	16	5.5	520*	Normal	A mature Oak located on the bank, exhibiting good physiological condition. Ivy is becoming established on the stem and lower branches. 2026: Minor deadwood is present within the canopy, consistent with the species and not considered significant.	Stem failure	4	1	7	-	<1/1M	Consider removal or severance of Ivy to allow for effective inspection and reduce potential long-term impacts.

Figure 6. Failed Plum tree within G9.

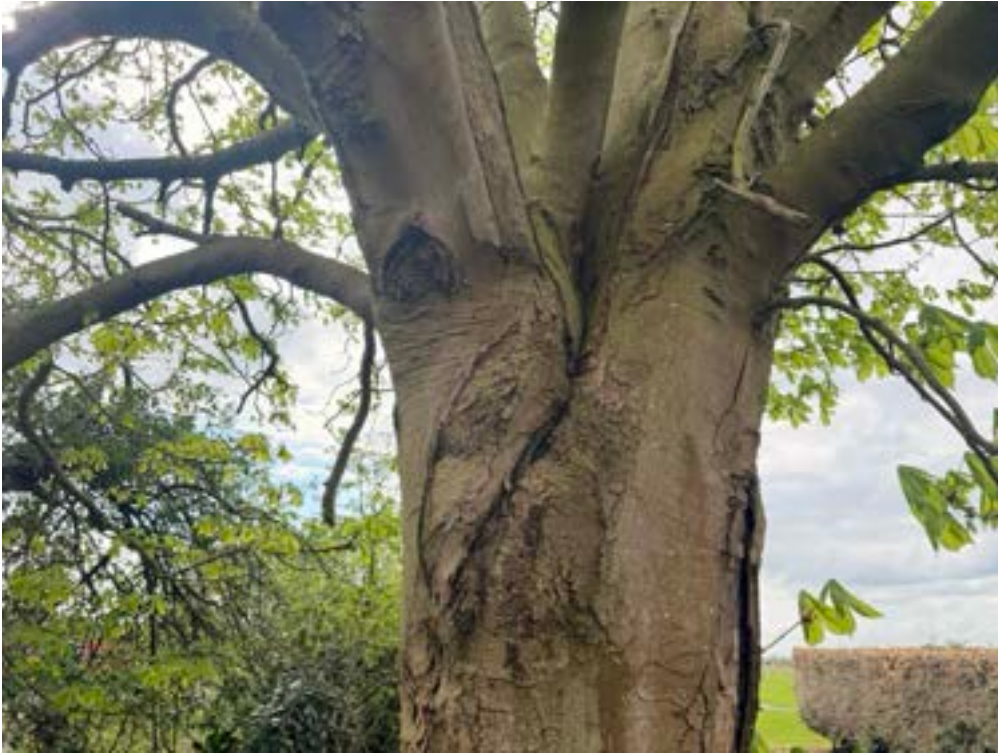
T11	Post Mature	Hawthorn (<i>Crataegus monogyna</i>)	6	0	110	Dead	A dead Hawthorn stem located within the hedgerow. 2026: No change; the tree remains in situ.	Stem failure	4	4	4	50%	<1/1M	No works recommended at present due to low target occupancy. Removal may be considered if site use changes.	
T12	Mature	Ash (<i>Fraxinus excelsior</i>)	9.5	5	590*	Normal	A mature Ash in good physiological condition, with no visible signs of Ash Dieback infection. Ivy is present on the stem and lower branches.	-	-	-	-	-	<1/1M	Sever or remove Ivy to improve inspection and reduce long-term competition. Continue to monitor for signs of Ash Dieback.	
T13	Mature	Horse Chestnut (<i>Aesculus hippocastanum</i>)	12	5	780	Normal	A mature Horse Chestnut exhibiting minor cambial damage at the base, including vertical areas of cambial dysfunction associated with bleeding canker. There is potential for internal decay. A bark-included union is present at approximately 2 m; however, there are currently limited visible signs of associated strain. 2026: Cambial damage remains evident, with secondary thickening appearing intact.	Union failure	3	1	5	-	<1/1M	No immediate works required. Continue to monitor the condition of the union and the progression of bleeding canker.	Fig. 7

Figure 7. A compression union within T13.

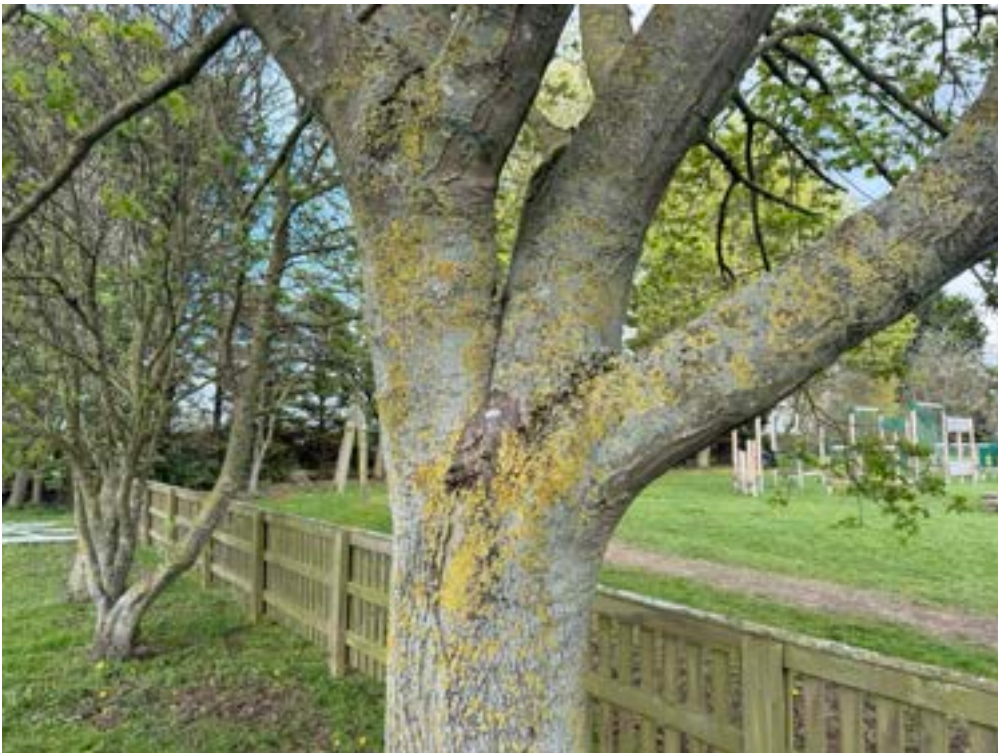
ID	Age Class	Species	Height (m)	Crown Spread	Diameter (mm)	Vitality	General Observations	Risk Assessment of	Target Range	Size Range	PoF	Reduce Mass to	Risk of Harm	Management Recommendations	Figure ref.
G14	Semi Mature	Rowan & Whitebeam (Sorbus)	6	3	150 ave	Normal	<p>A group of approximately 16 Rowan and Whitebeam trees growing in close proximity. Several trees exhibit rabbit damage at the base, with some early-stage decay evident; however, this is not currently considered significant to structural stability.</p> <p>Two suppressed trees beneath T15 have died due to competition. Their size and location mean they do not present a significant risk.</p>	Stem failure	3	3	6	-	<1/1M	No work required. Natural attrition within the group is acceptable given low target occupancy.	
T15	Mature	Norway maple (<i>Acer platanoides</i>)	12	6	480	Normal	A mature Norway Maple with a bark-included union at approximately 2 m. The level of associated strain appears limited at present. Minor deadwood is present within the canopy, typical of the species and not considered significant.	Falling deadwood	4	4	4	50%	<1/1M	No works required.	Fig. 8

Figure 8. A compression union within T15.

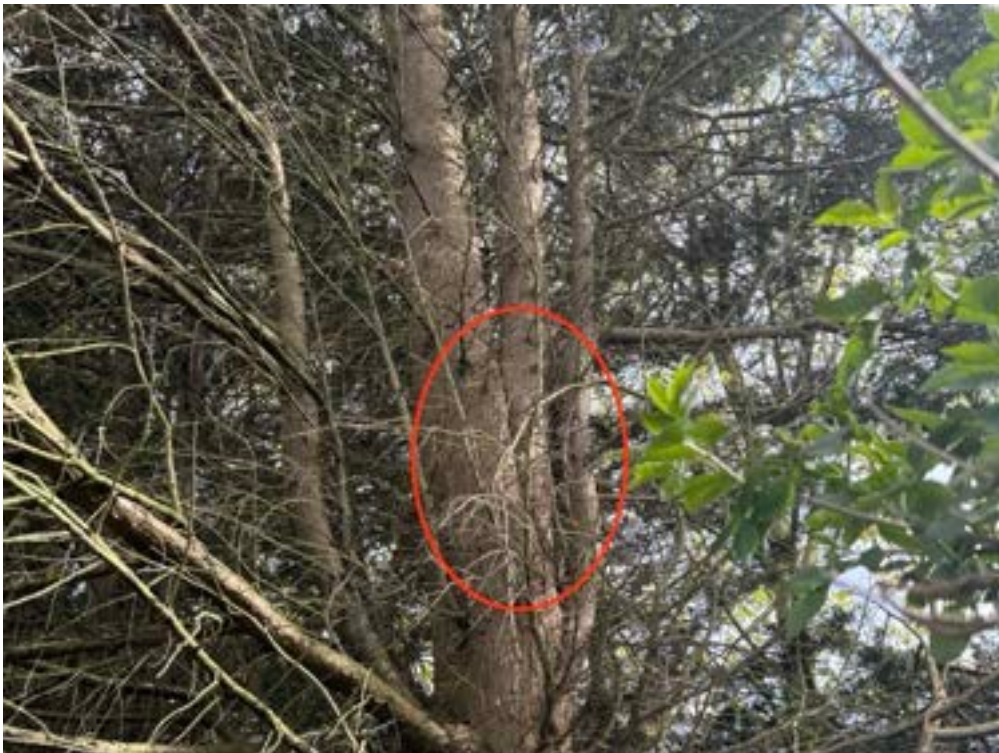
G20	Mature	Mixed	13	4	400 ave	Normal	A mixed species group comprising Holly, Birch, Plum, Cherry, Cypress, and Lime. The trees are generally well developed, with no significant structural defects observed. Some specimens exhibit minor reductions in vigour; however, this is not considered significant.	-	-	-	-	-	<1/1M	No work required.	
G21	Early Mature	Mixed	5-10	3	N/A	Normal	A mixed species group surrounding the car park, including Hawthorn, ornamental Pear, Whitebeam, and Norway Maple. The trees are in good condition with no significant defects observed. Those adjacent to the pavement appear to be subject to regular canopy lifting.	-	-	-	-	-	<1/1M	Continue cyclical canopy management to maintain a minimum clearance of 2 m above the pavement.	Fig. 10

Figure 10. A compression union within a cypress tree within the G20 group.

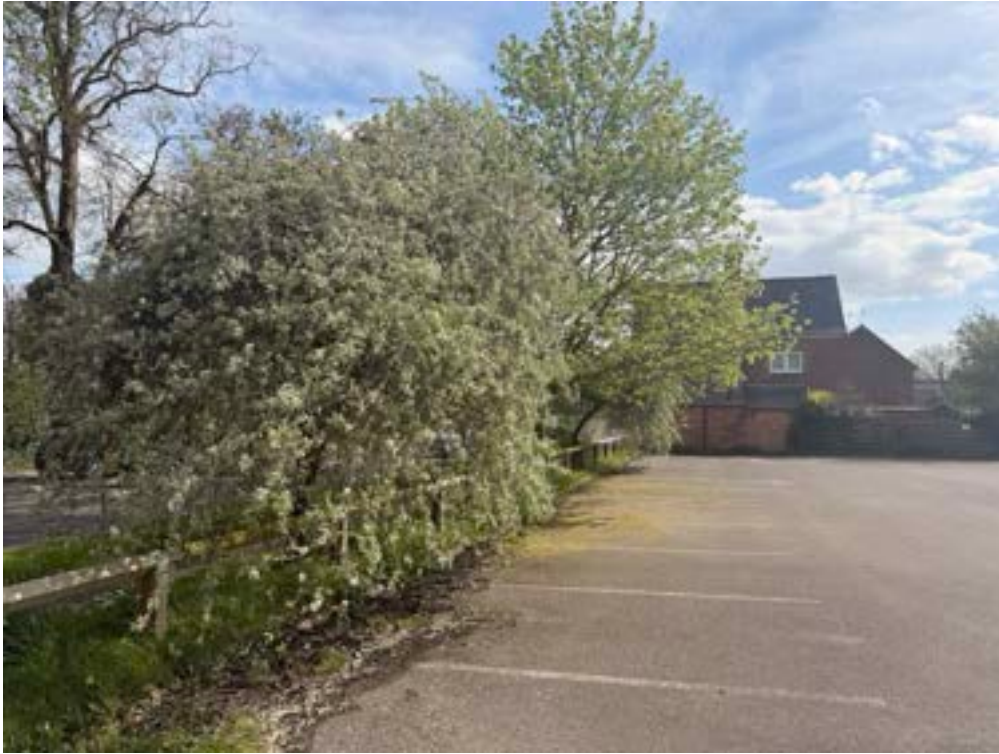
Figure 11. Trees from the G21 group are growing into the car park.
